Tyre damage: Causes and avoidance

Car tyres 2013 - 14

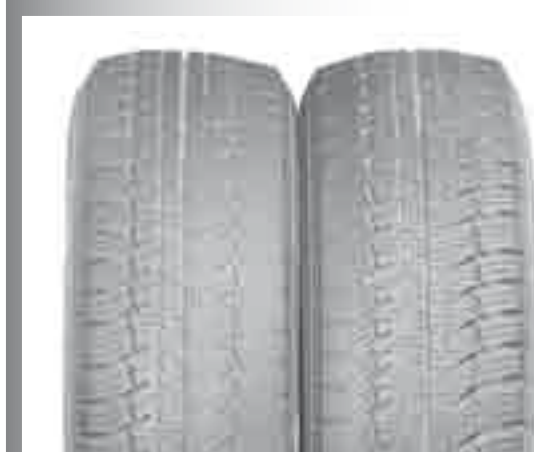
Increased, one-sided wear due to "slip". It is frequently encountered in connection with a worn tread surface. This is also often seen together with burrs along block edges up to worn tyre shoulders.

Tip If a vehicle's wheels are misaligned, the wheels must be aligned and the deviation corrected.

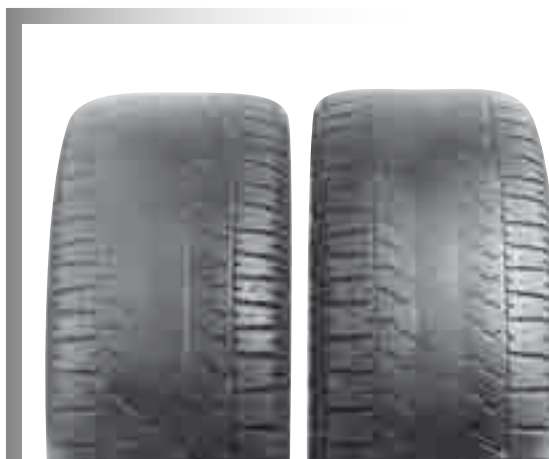
This wear pattern is found on powered wheels of highly motorised vehicles. Even today's mid-range cars have **modern engines generating high levels of torque** and capable of producing high degrees of slip.

These high torque levels, during strong acceleration or in stop-start urban traffic, or when accelerating away from traffic lights, can quickly increase wear of the tread centre.

Example of tyre wear pattern on powered axle of a powerful car: pronounced wear is visible in the tread centre.

Tip By rotating the wheels from the powered to the nonpowered axle before it is too late, it is possible to obtain a largely uniform pattern of wear. Always observe the vehicle manufacturer's recommendations.

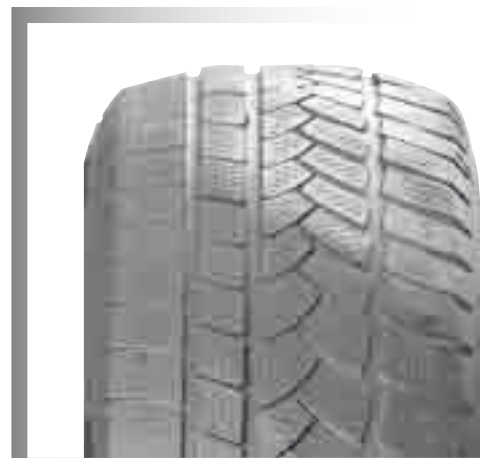
Diagonal spot wear runs at an angle of about 45° to the circumferential plane. It usually occurs on the circumference of the tyre only once, although multiple instances are also known.

Spot wear is restricted more or less to nonpowered wheel positions, especially the rear left position. Some vehicle models are particularly susceptible to spot wear, while others are not affected at all. The effect is aggravated by high toe-in values (see page 6).

This is because the toed-in tyre rolls at a slip angle, even when the vehicle is travelling straight ahead. The result is diagonal warping

Tip To avoid wear of this nature, the toe-in values should lie at the lower end of the tolerance range specified by the vehicle manufacturer. The tyres should be properly inflated. At the first sign of spot wear, the wheels concerned should be transferred to the powered axle. Vehicle manufacturer's specifications must be observed.

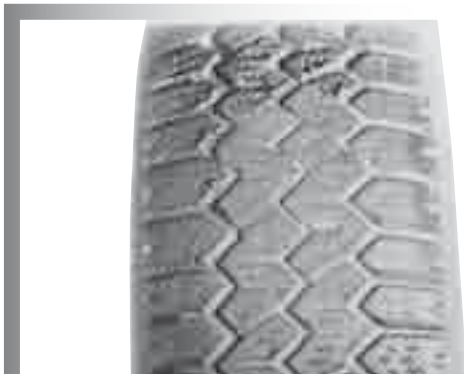
Braking flat spots are the **result of full braking** with locked wheels, causing the tyre to "lay rubber".

Severe wear due to full braking (without ABS).

Tip Extreme wear of this kind is responsible for a certain amount of vehicle vibration. This problem cannot be eliminated by balancing the wheels. The tyre can no longer be driven and must be replaced.

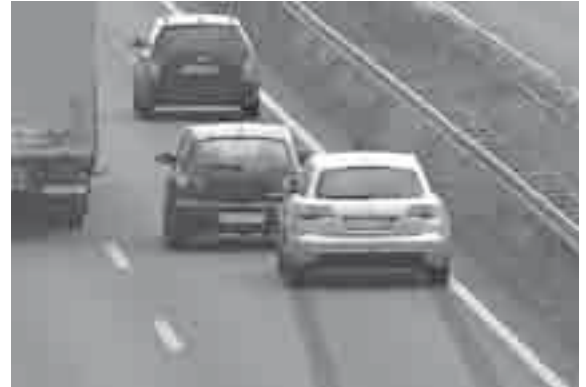
Brakes can lock briefly even on vehicles equipped with ABS (antilock brake system), causing minor flat spotting.

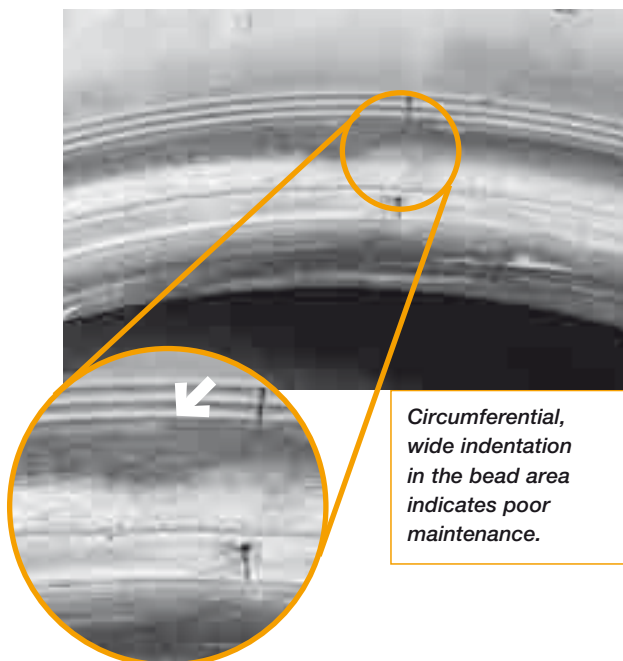
The tyre shown here was occasionally driven with inflation pressure insufficient for the load. Noticeable signs of this are circumferential, wide tracks in the bead area, where the tyre chafed against the rim flange, and shoulder wear on both sides. Discolouring or "compression wrinkling" of the inner liner at the level of the sidewall, indicate that the tyre has been driven in an underinflated state.

Circumferential, wide indentation in the bead area indicates poor maintenance.

Tip *Damage of this kind can be avoided if the tyres are regularly checked to ensure that they are correctly inflated and if care is taken not to exceed the tyre's specified load capacity.*

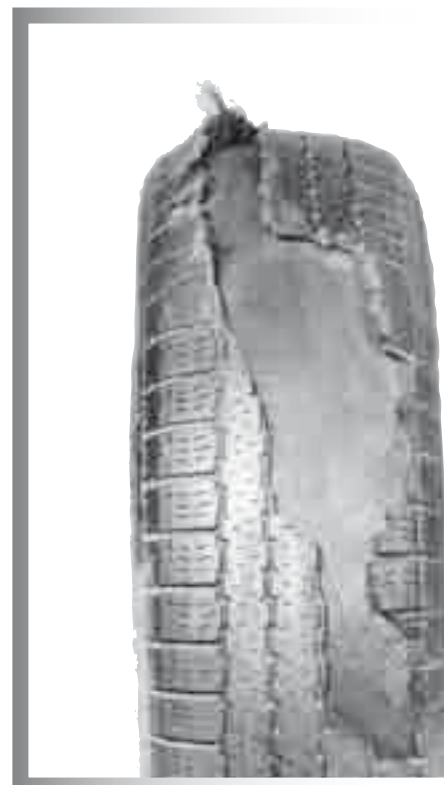
The tyre's contact patch is deformed when rolling. This can result in high shearing between different components. If a tyre is improperly serviced and driven in an underinflated state and/or with excessive load, it heats up beyond the critical temperature range, resulting in partial separation of plies (partial tyre disintegration).

Damage of this type usually develops over a longer period of time. If the already damaged tyre is then subjected to a high level of stress, parts of the tyre may detach due to the enormous centrifugal forces at work on the tyre at high speeds.

Parts of the tyre have torn off as a result of poor maintenance.

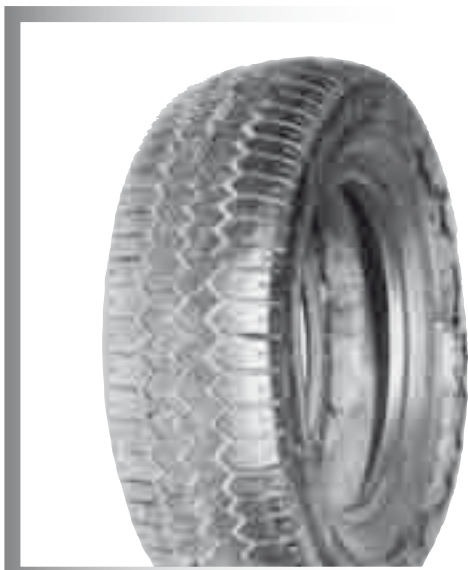
Major heat build-up in the tyre due to driving in an underinflated state led to separation of structural components and to melt-down of the rubber.

Tip Damaged valves and rims must be replaced with new ones. The valve should be replaced each time a tyre is fitted. If a direct tyre pressure monitoring system is fitted, the sealing-ring on the sensor should also be renewed. Always observe the specifications of the system manufacturer, e.g. Beru or Schrader.

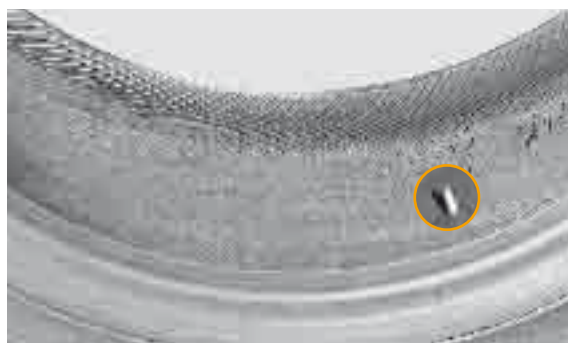
Circumferential discolorations of the sidewall in the flexing zone are indications of extended trips with falling inflation pressure or low inflation pressure.

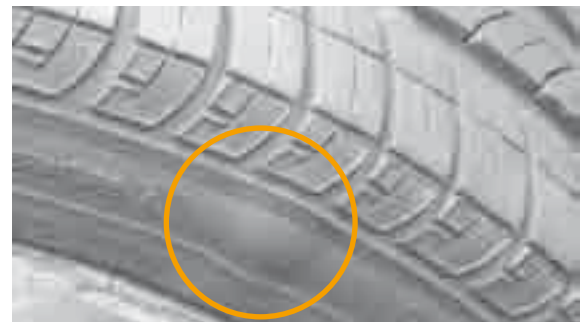
Usually an externally visible bulge on the sidewall of the tyre indicates that cords have been destroyed inside the carcass. If such damage is ignored there is the risk of tyre failure at some time in the future, usually delamination of the tread and/or plies or disintegration of the tyre flank.

Damage of this kind is typically caused by driving over objects – like kerbs or speed bumps – at excessive speed and/or at the wrong angle. This overstresses the carcass and can cause individual cords to break.

Damage seen from outside.

Tip Kerbs and similar obstacles should only be driven over at an obtuse angle and at appropriately slow speed.

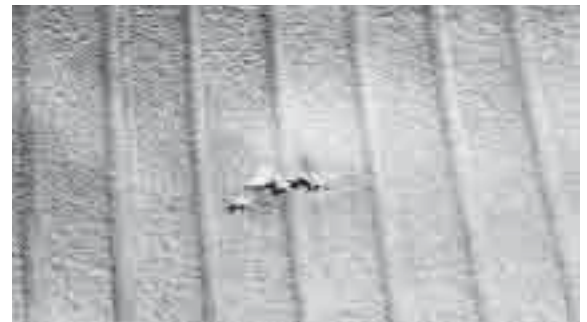
The carcass was jammed up against the rim flange as a result of a strong impact and has split in the area of contact. (Damage seen from inside the tyre)

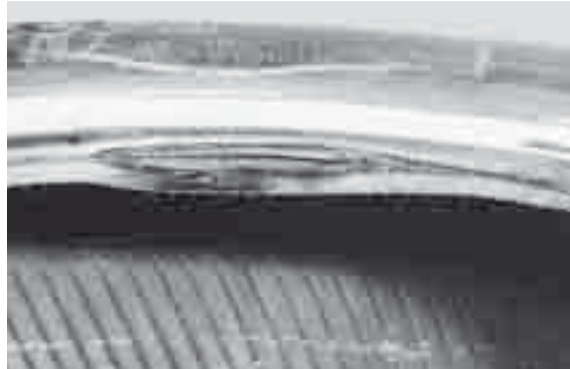
- ▶ the opposing bead section is not completely inserted in the drop centre of the rim;
- ▶ the mounting head on the machine is not properly adjusted or the mounting shoe is worn (sharp-edged);
- ▶ the edge of the mounting roller rolls off the base of the bead.

In the damaged area, the guide roller frequently leaves marks where it has made contact with the tyre. The likelihood of damage occurring increases if the guide rollers used have developed sharp-edges as a result of wear.

Bead damage caused during fitting.

Both beads and the rim shoulders must always be sufficiently lubricated before fitting. Undetected fitting damage can result in the tyre failure at a later date.

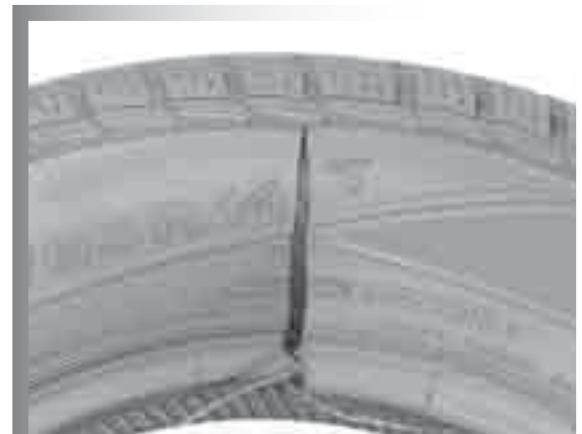
When the tyre is inflated in the process of mounting, part of the bead may get caught on the hump. In this case there is a danger of the bead excessively expanding if the tyre is overinflated and of some or all of its steel wires breaking. The pressure exerted to get the bead over the hump **must not**, for this reason, **exceed 3.3 bar**. If the tyre cannot be properly mounted at this pressure, the fitting process must be stopped. The rim flange and tyre beads should be checked to ensure that sufficient fitting lubricant has been applied. If required, additional fitting lubricant should be used. The tyres can now be fit again.

Ruptured bead as a result of tension during inflation of a tyre.

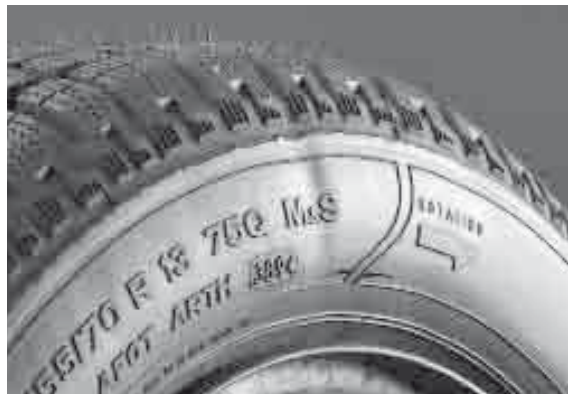
It is this seam which is sometimes visible as an indentation after the tyre is fitted and inflated with air – although usually they are more or less invisible.

Indentation at the carcass ply overlap seam.
