Tyre damage: Causes and avoidance

Car tyres 2013 - 14

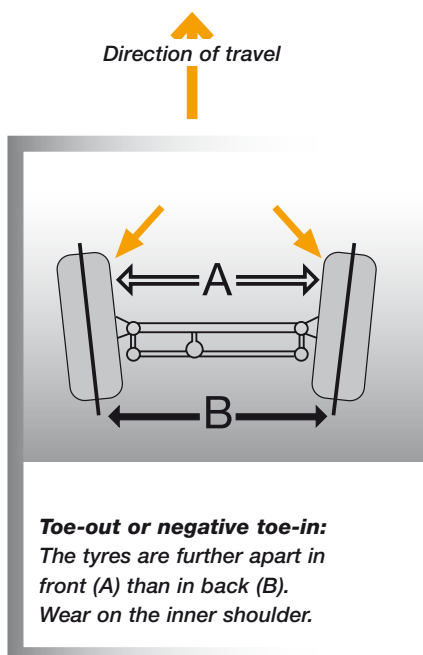
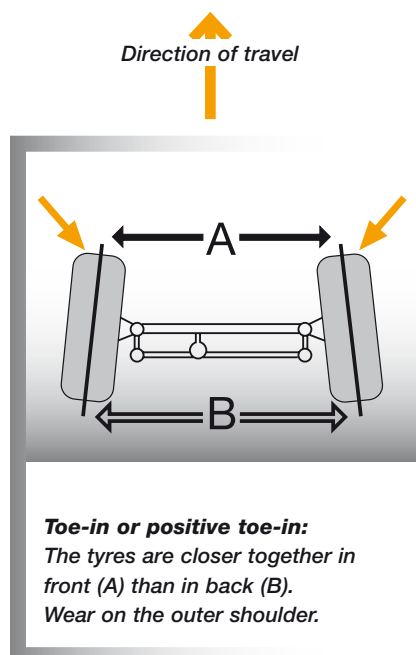
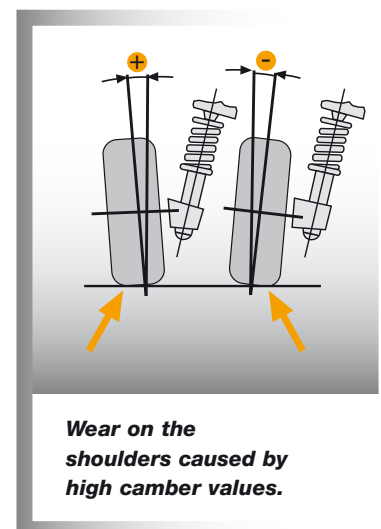
One-sided wear

The most frequent cause of one-sided wear is a **wheel geometry in deviation of specifications**.

This might go unnoticed as all wheel alignment values are still found to be within tolerance limits when measured statically on the axle measurement bench. The result may be an increase in nonuniform wear.

Increased, one-sided wear due to "slip". It is frequently encountered in connection with a worn tread surface. This is also often seen together with burrs along block edges up to worn tyre shoulders.

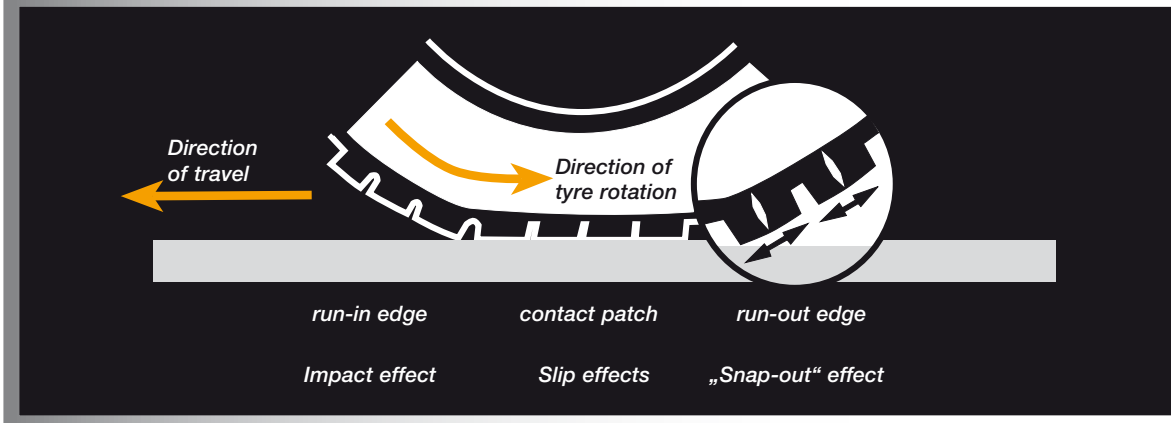
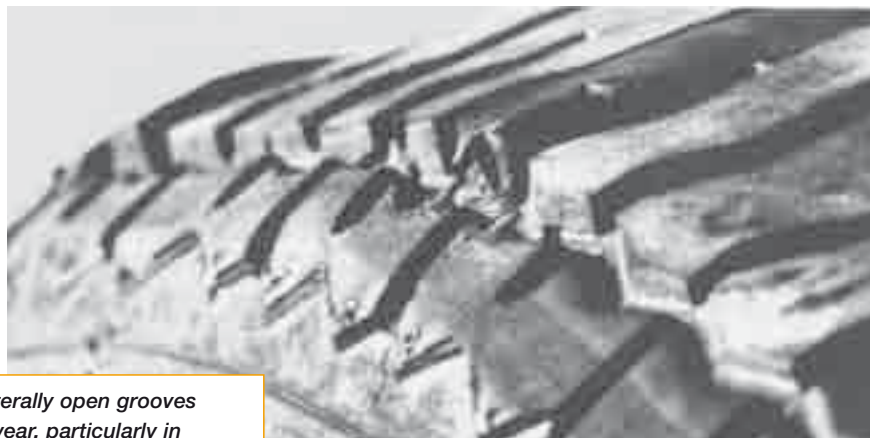
Creation of "saw-tooth wear"

Tyres with large blocks or laterally open grooves are susceptible to stepped wear, particularly in non-powered wheel positions. The blocks exhibit more pronounced wear on the rear edge (relative to the direction of tyre rotation) than on the front (leading) edge, giving the blocks a characteristic saw-tooth wear pattern when viewed from the side.

A minor amount of "saw-tooth" pattern wear is normal and has no discernible effects on comfort.

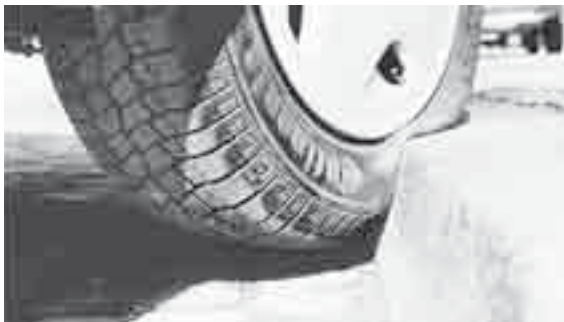
Damage seen from outside.

Tip Kerbs and similar obstacles should only be driven over at an obtuse angle and at appropriately slow speed.
